Correlation Study of IR TNDT Analysis with Structural Failure Modes of Carbon-Fabric-Reinforced Epoxy Composites

ABSTRACT

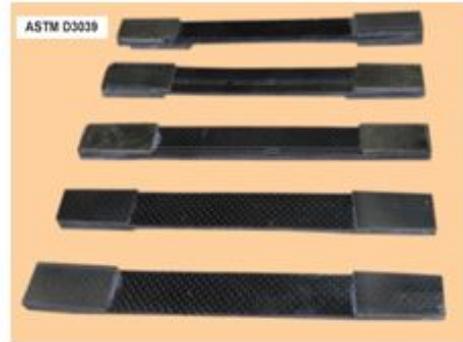
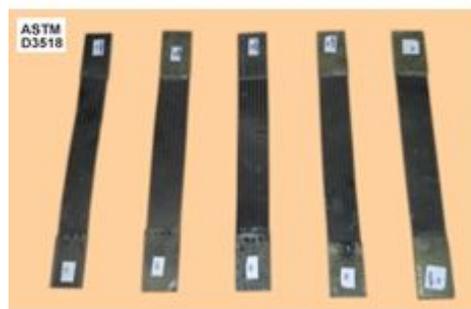
FIGURE 2. Carbon Fabric/Epoxy Composite Test Coupons.

The ASTM standards of the various tensile test specimens which are shown in *Figure 2a, 2b, 2c* and *2d* are referred from literatures [15-17]. All the specimens have an overall length of 250 mm. The composite test coupon specifications and mechanical testing procedures are detailed in the proceedings of ASTM [14-16]. In the present work, the carbon fabric/epoxy test coupons in four configurations were fabricated by hand lay-up technique [10, 23] at room temperature curing.

(a)CFRP Plain Coupon

(b)CFRP Dumb Bell Coupon

(c)CFRP Coupon with End Tab

(d)CFRP $\pm 45^\circ$ Coupon

Sample No.	STANDARD	CFRP Test coupon Configuration	Range of averaged Thickness, mm	Qty
#1	ASTM D3039 (Fig.2a)	Coupon Without End Tab	2.56-2.99	5
#2	ASTM D638 (Fig.2b)	Dumbbell Shape Coupon	2.31-2.64	5
#3	ASTM D3039 (Fig.2c)	Coupon With End Tabs	2.29-2.86	5
#4	ASTM D3518 (Fig.2d)	$\pm 45^\circ$ Coupon With End Tabs	2.8-3.26	5

Poisson's ratio has been estimated by carrying out tensile tests using plain coupon (*Sample#1, Figure 2a*) which makes use of flat laminate of 250 mm long, 25 mm wide by employing electrical strain gauges. In this test method, electrical strain gages (120 Ohms resistance with a gage factor of 2.15) are pasted along the longitudinal and transverse direction in carbon fabric/epoxy test coupon as shown in *Figure 7* for the evaluation of the Poisson's ratio value through the strain data acquisition system (Model – 5100B Scanner with 5 channels).

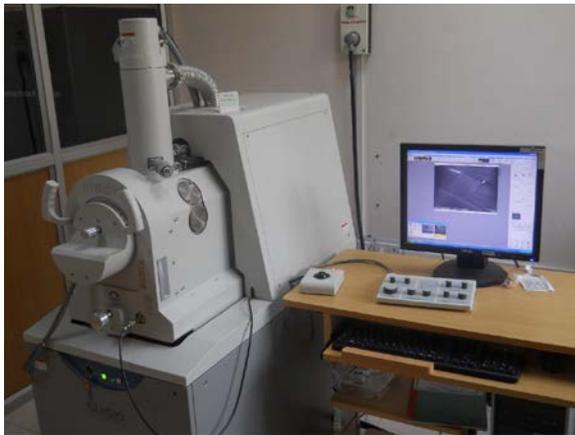
FIGURE 8. SEM Test Setup.

Scanning Electron Microscope* (Model: SU-1510, 2009) shown in Figure 8 has been used for the observation of the fracture mechanism [26-28] of tested samples of carbon fabric/epoxy composites.

The SU 1510 SEM utilizes an electron beam accelerated in the range of 300eV to 30keV. To prevent image interferences due to charging-up when a secondary electron image of a non-conductive specimen such as FRP specimen are observed with SEM, a metallic film of 2-25 nm thick of an alloy such as Au-Pd is coated on the effected portions of surface of the carbon fabric/epoxy composite specimen with the sample preparation instrument namely, Ion Sputter E-1010*. To enhance the image quality, the surface of the specimen is coated with Au-Pd.
